Draft Navigation Impact Report

Key No. 22266: SH-52 Snake River Bridge
Bridge Replacement Project

Prepared for the Idaho Transportation
Department

Payette County, Idaho & Malheur County, Oregon
September 12, 2023

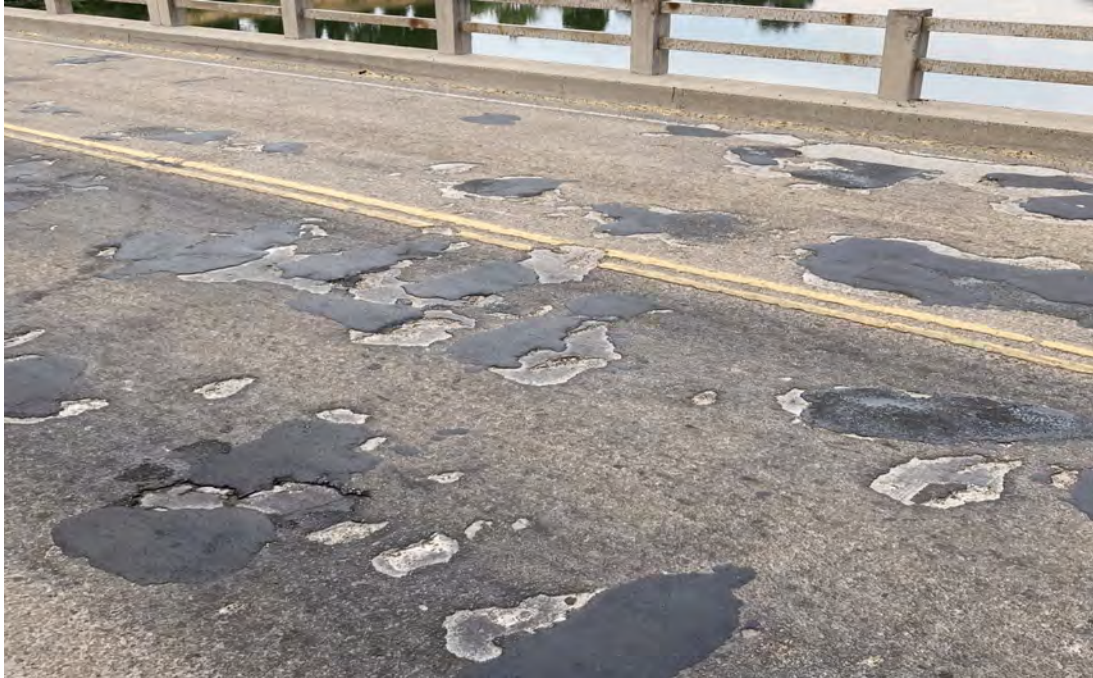
5. Typical deck topside condition

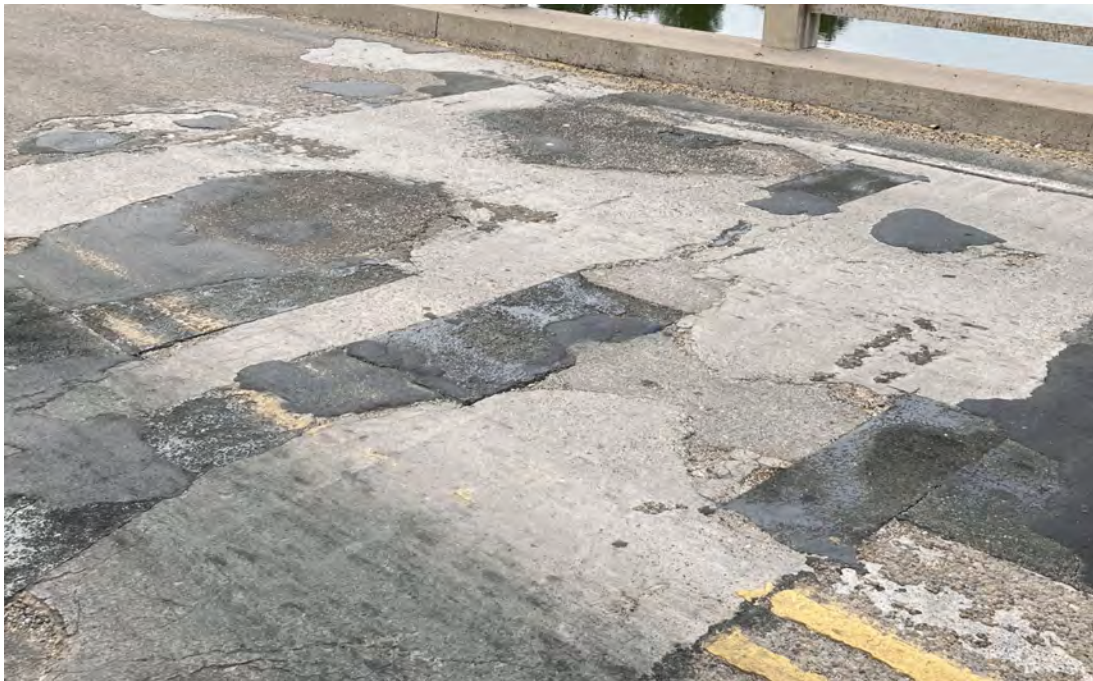
There is a full depth deck repair in span 3 between floor beams 15 & 16. This repair has open spalls with exposed rebar on the surface (most of the spalls have been patched but some still remain unpatched) and map cracking with efflorescence and spots of rust staining on the underside.

6. Typical deck topside condition (full depth patch, span 3, FB 15-16)

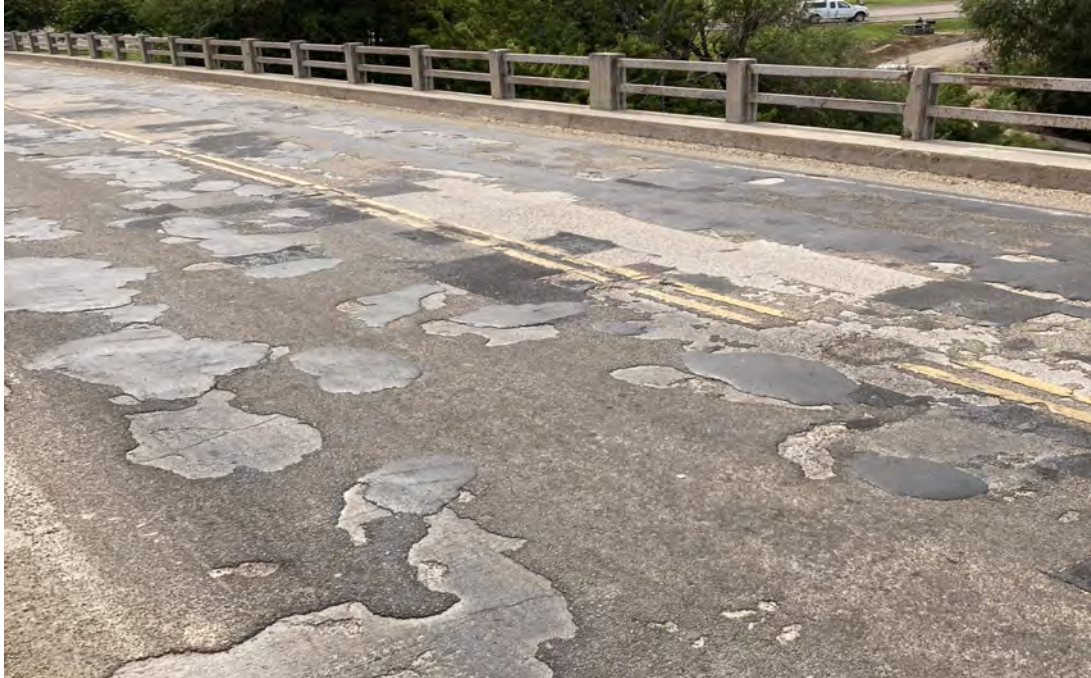
7. Typical deck topside condition

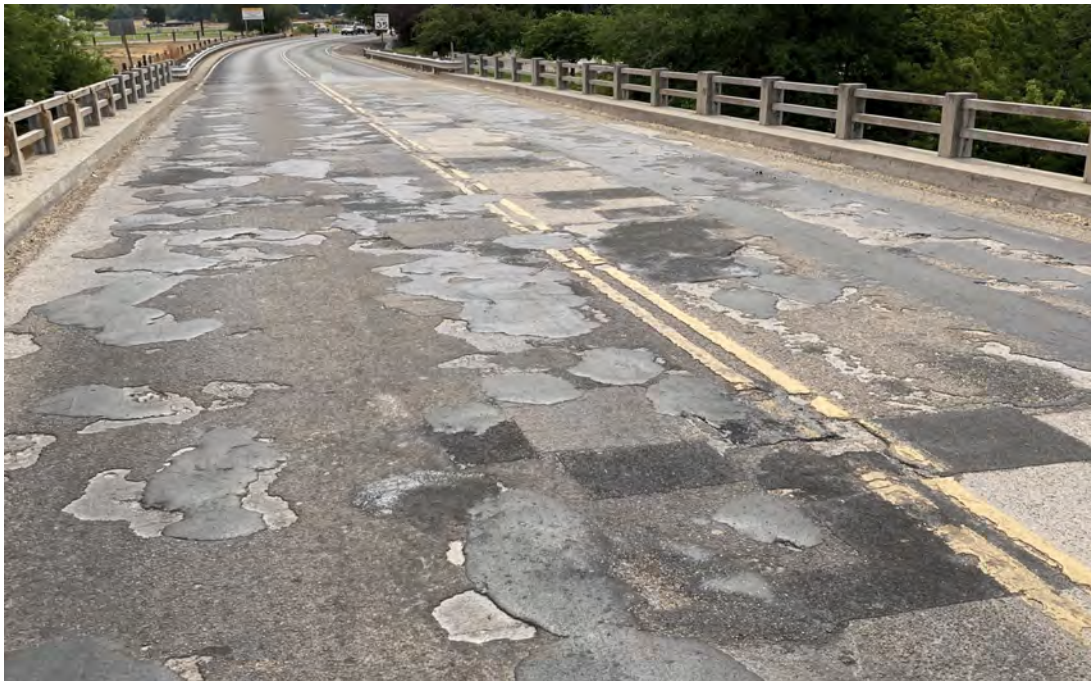
The deck surface in spans 2, 3, 4, and 5 have numerous open spalls with span 4 being the worst. A high percentage of the deck surface in span 4 is spalled. These spalls are typically shallow with areas of delamination around them. These areas also have water stains which indicate deteriorated concrete. Since 2018 a majority of the open spalls in the deck surface have been covered with a Maxwell product called Gap Mastic 550 (placed on the first week of December 2019). This is not a structural repair, this is just to make the driving surface smoother.

8. Typical deck topside condition (span 4)

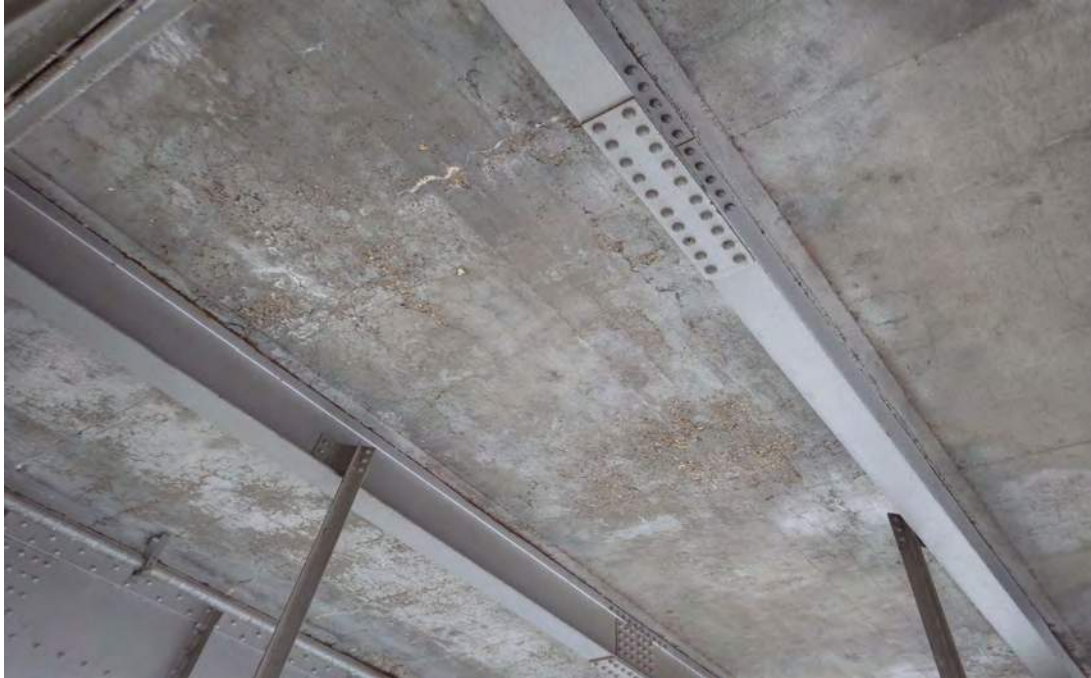
9. Typical deck underside condition (span 4)

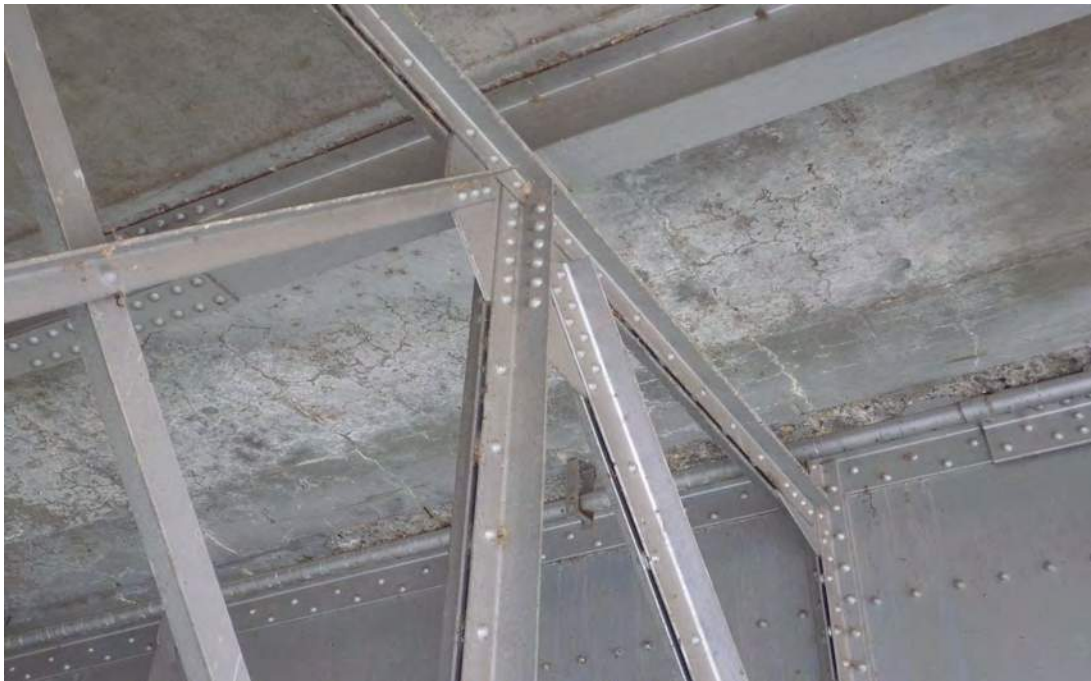
10. Typical deck underside condition (span 4)

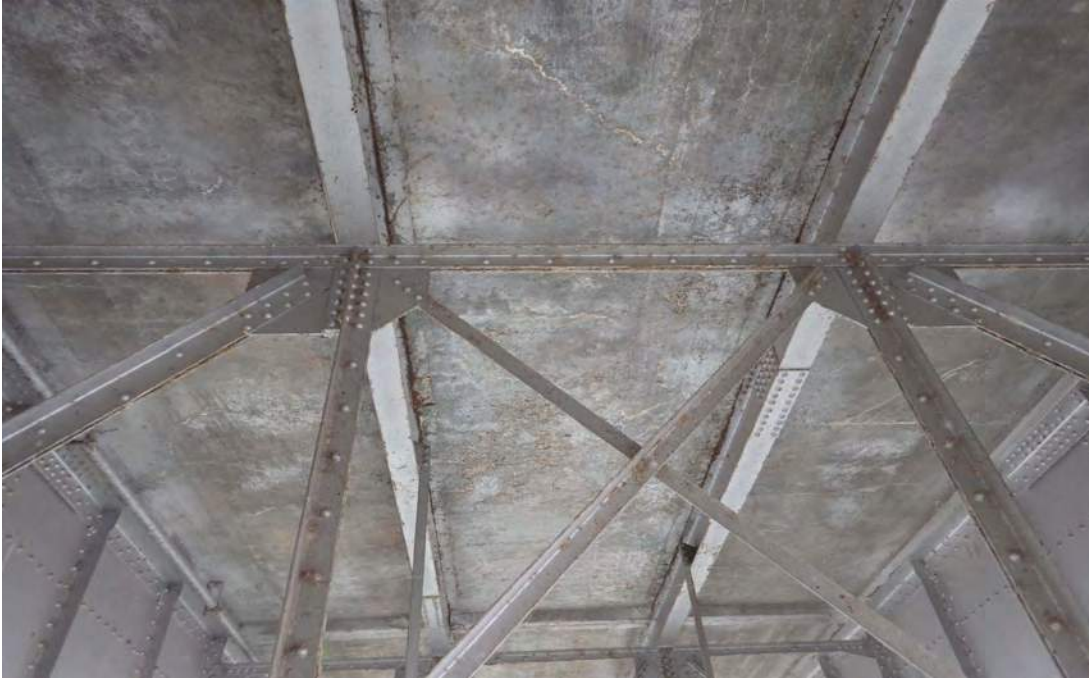
11. Typical deck underside condition (span 4)

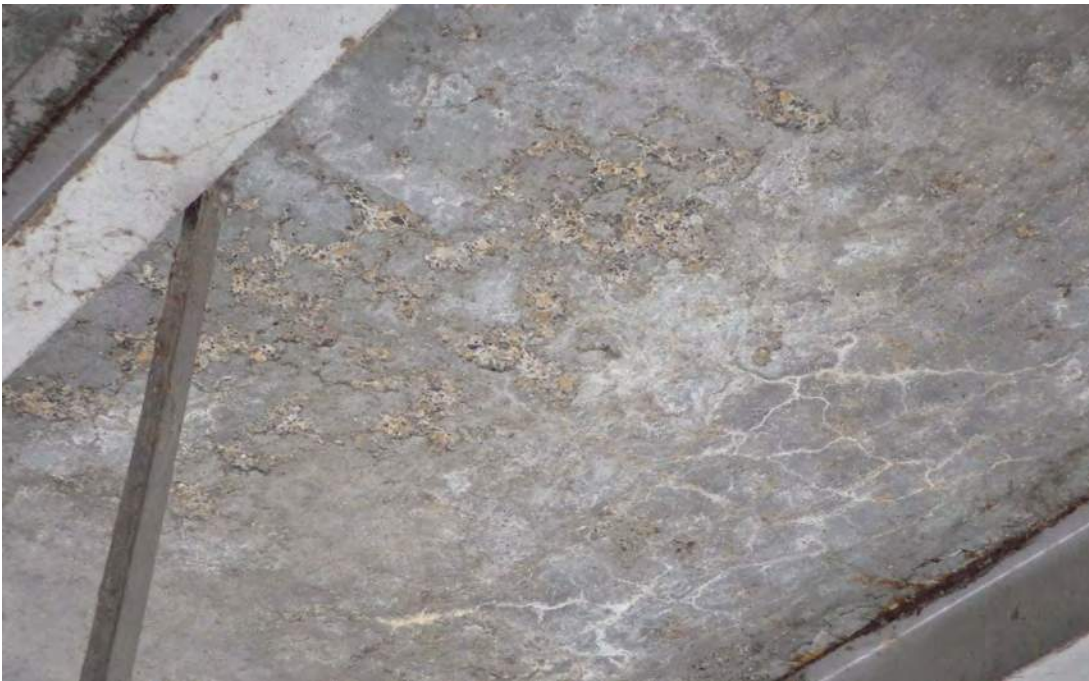
12. Typical deck underside condition (span 4)

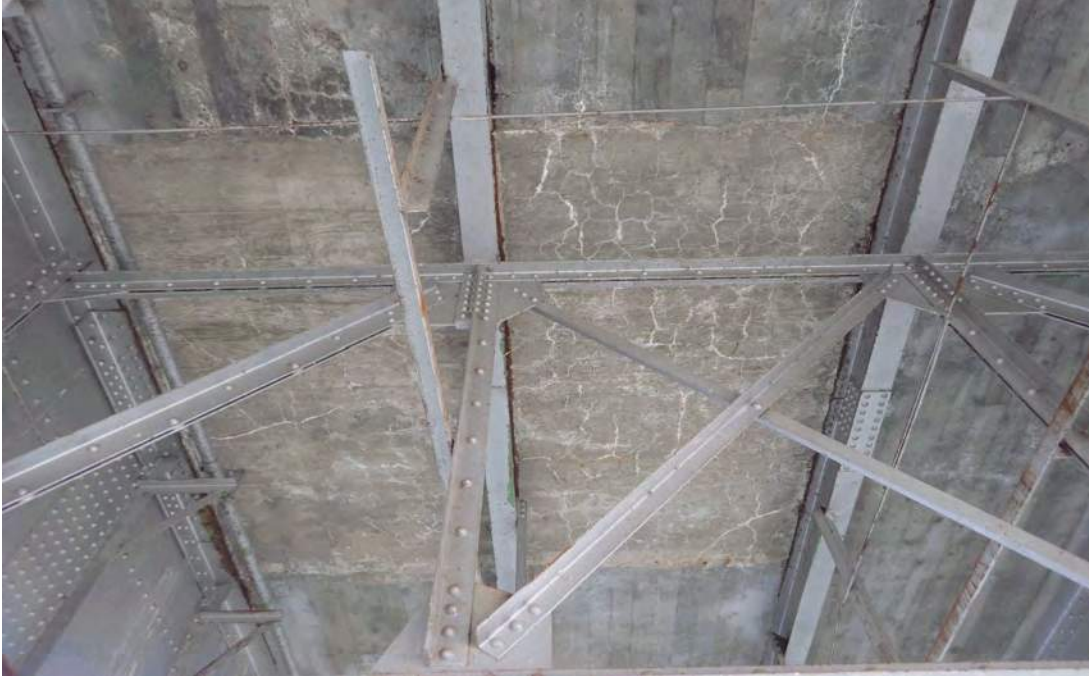
13. Typical deck underside condition (full depth patch, span 3, FB 15-16)

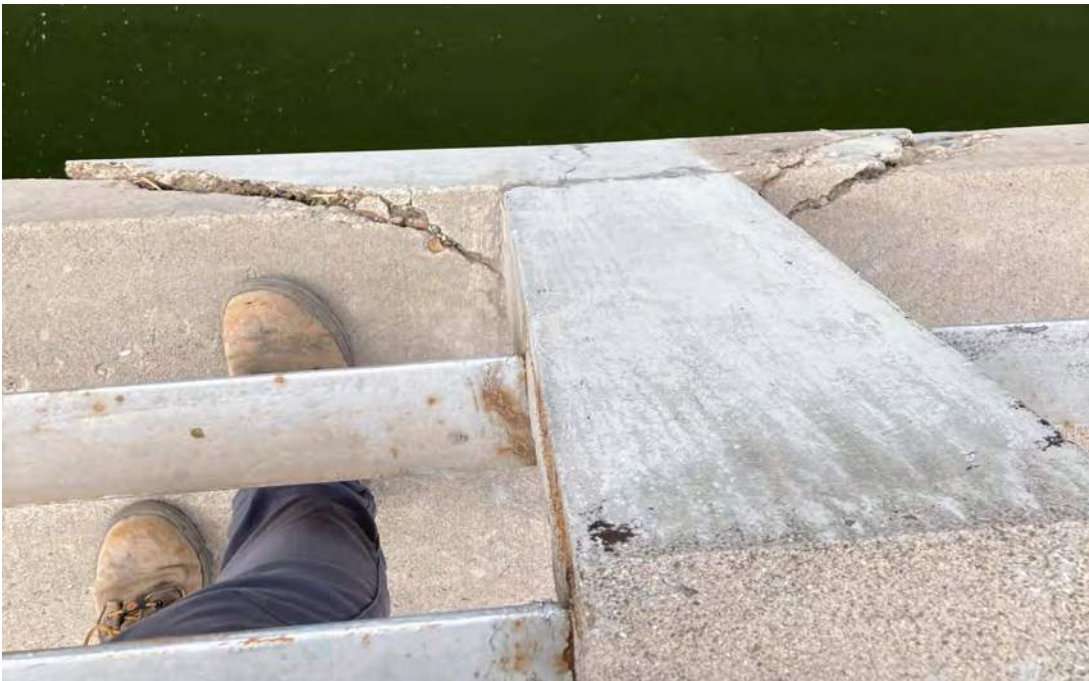
14. Spall in right deck exterior, span 4, at FB 26 due to rail collision damage (topside)

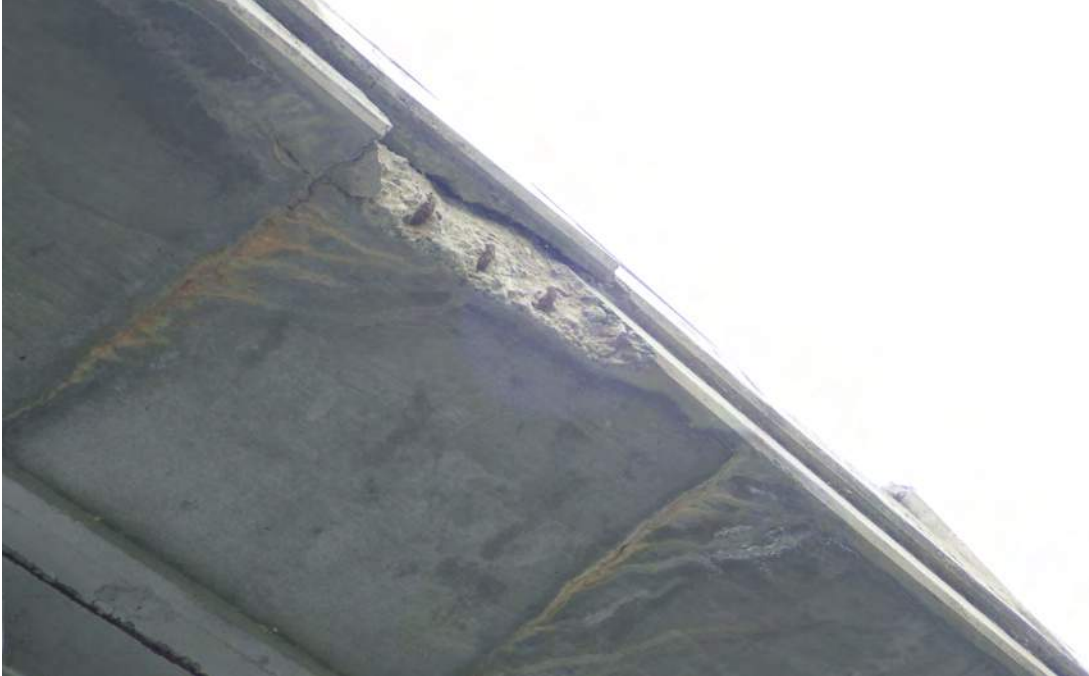
15. Spall in right deck exterior, span 4, at FB 26 due to rail collision damage (underside)

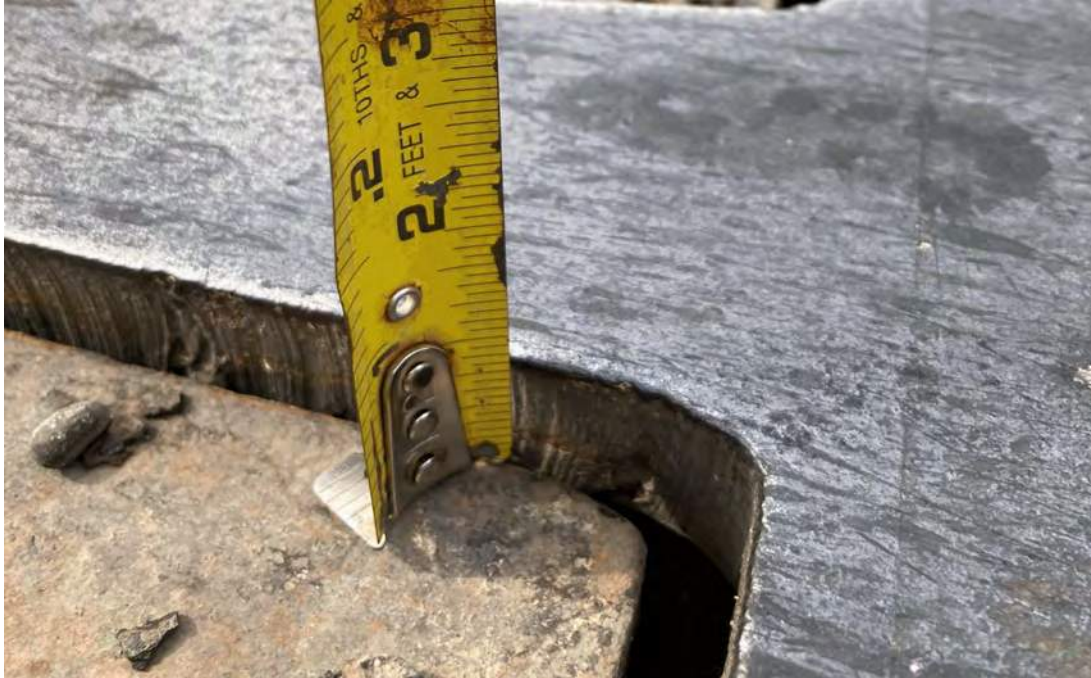
25. Finger joint vertical offset

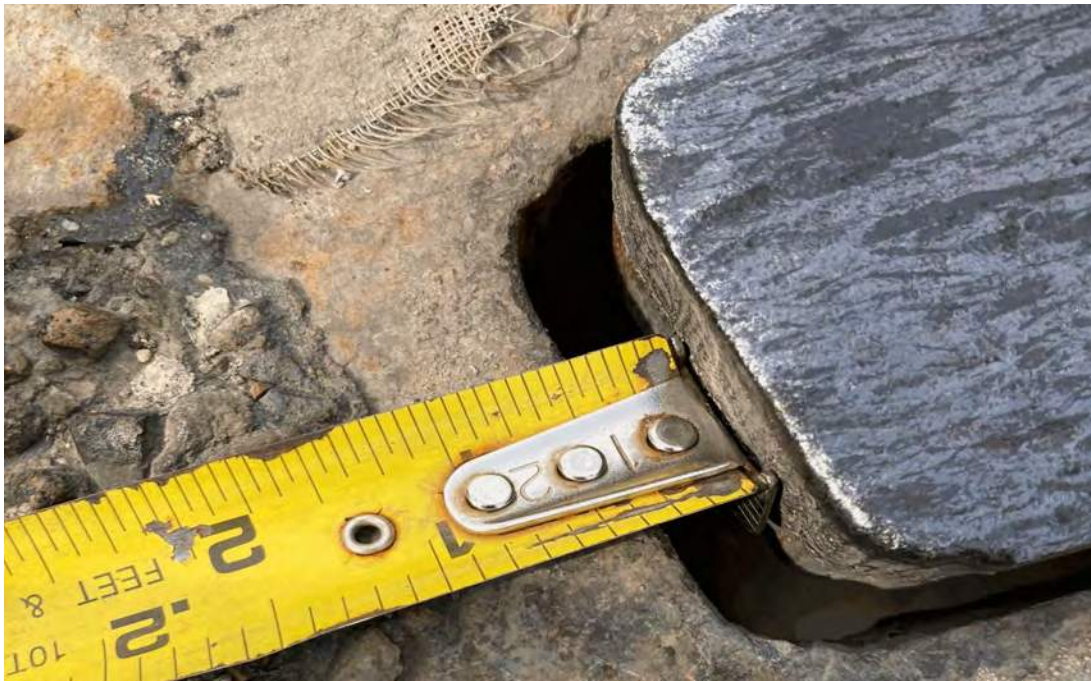
26. Finger joint opening

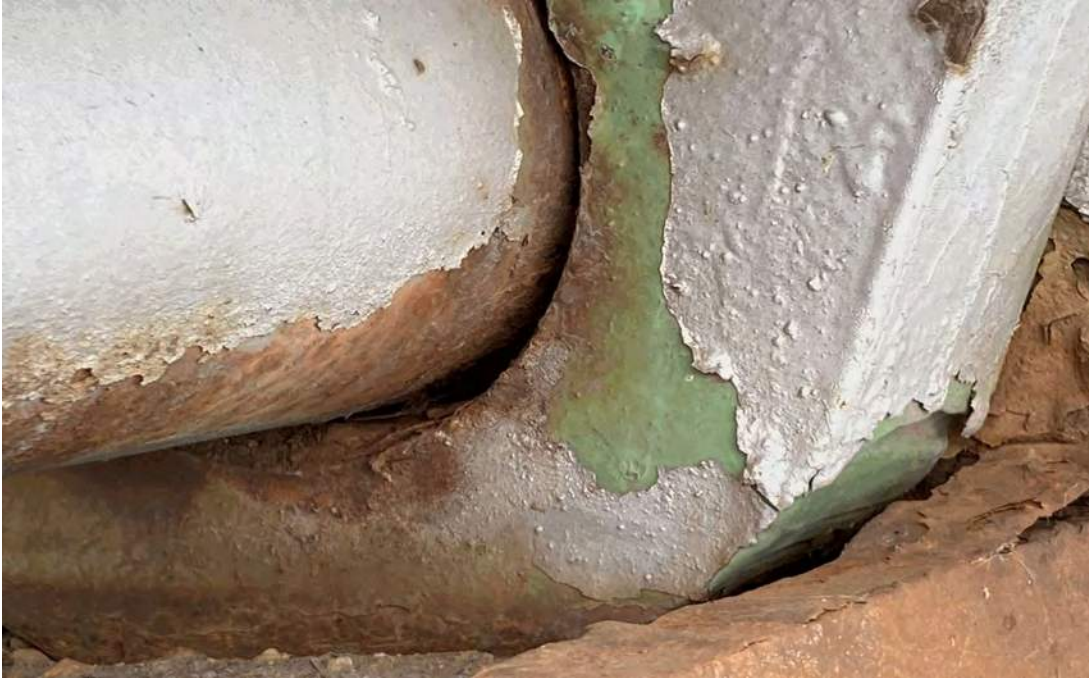
27. Typical pin wear at pier 1 (span 2, girder 2 bearing)

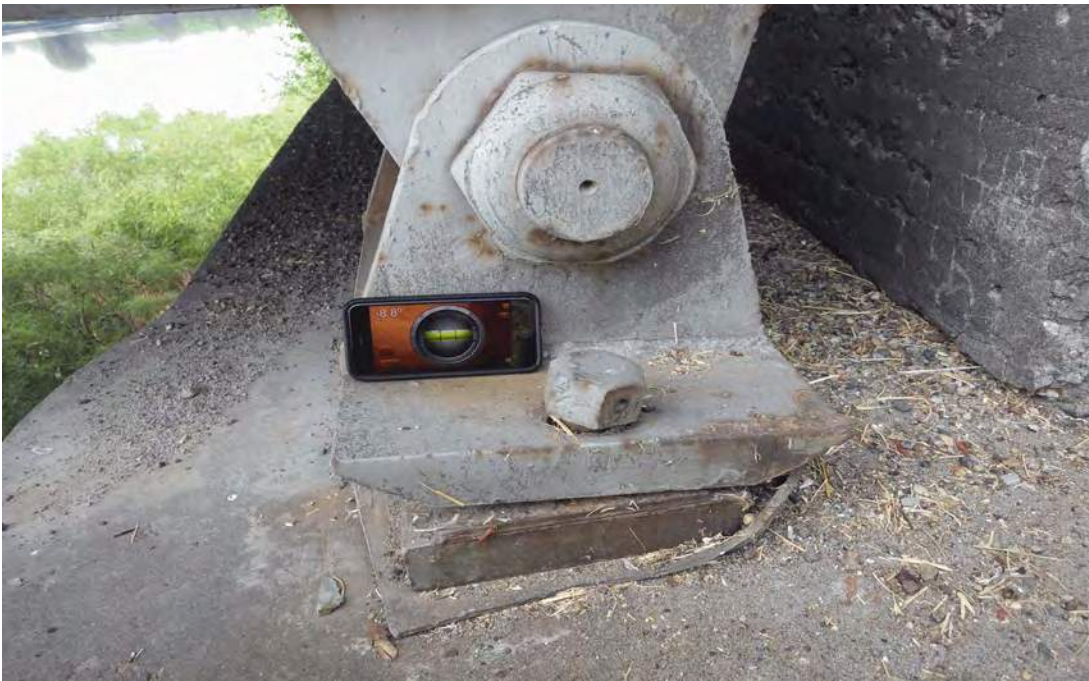
28. Girder 1 bearing tilt at pier 1

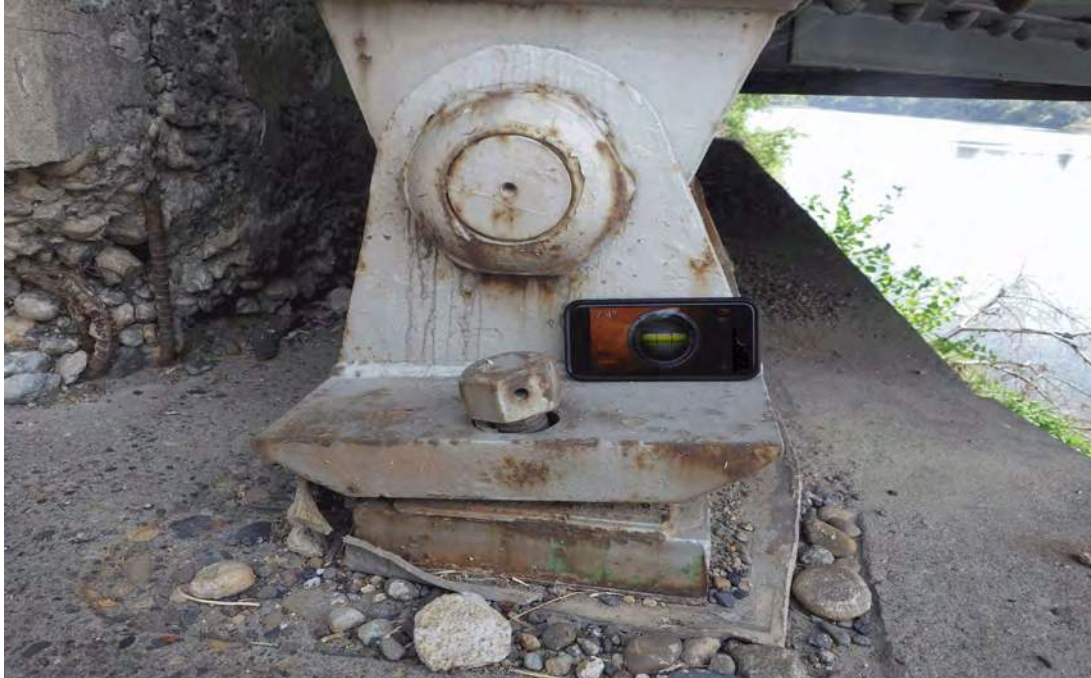
29. Girder 2 bearing tilt at pier 1

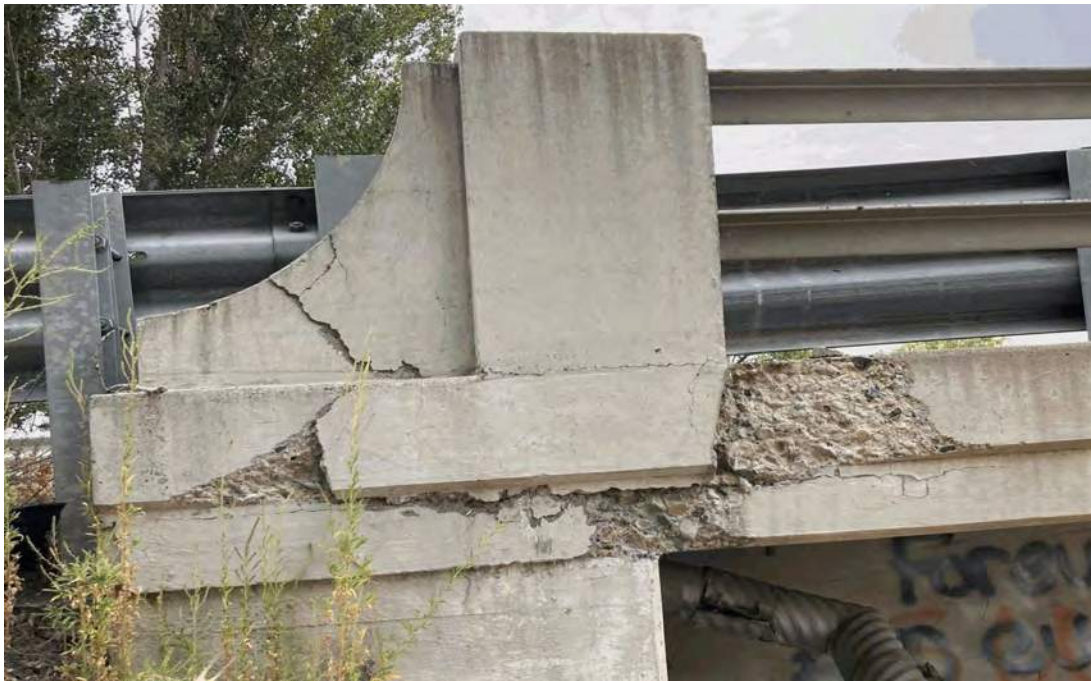
30. Rail end block/curb/deck exterior damage, right side abutment 1

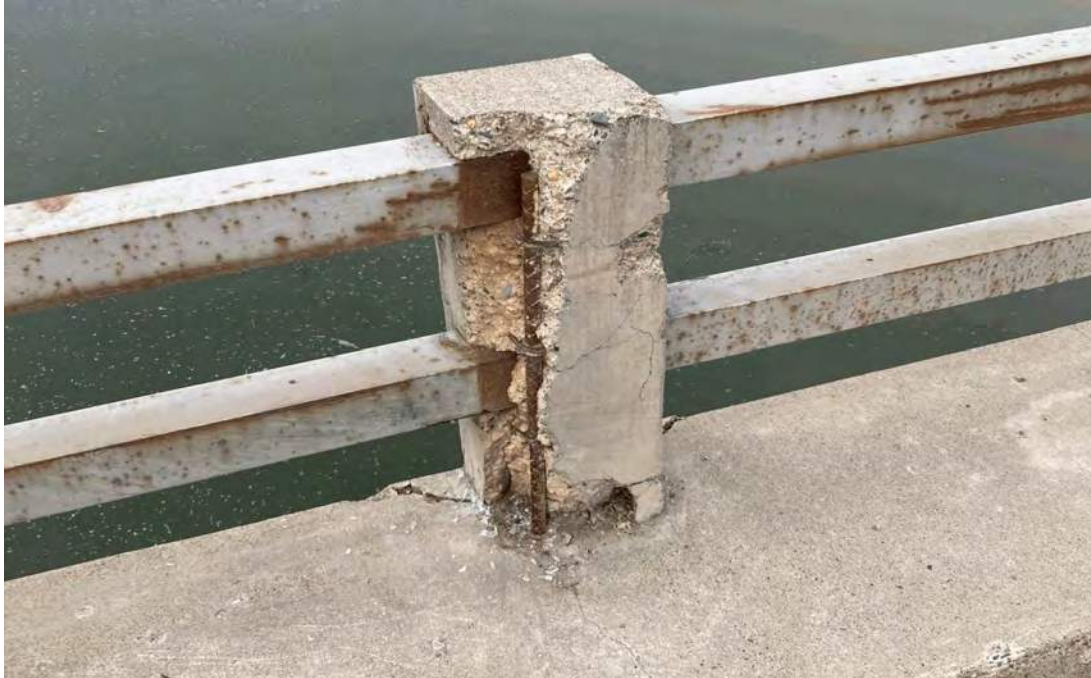
31. Typical rail post damage (right rail, span 4)

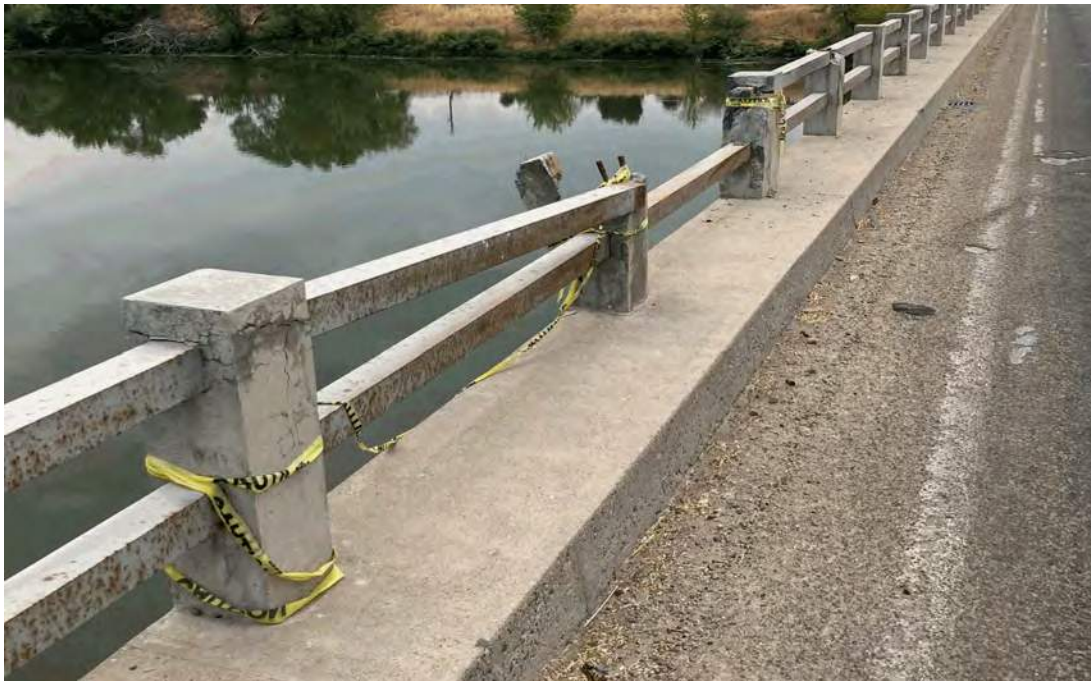
32. New rail damage, left rail, span 2, about 6 rail posts away from pier 3

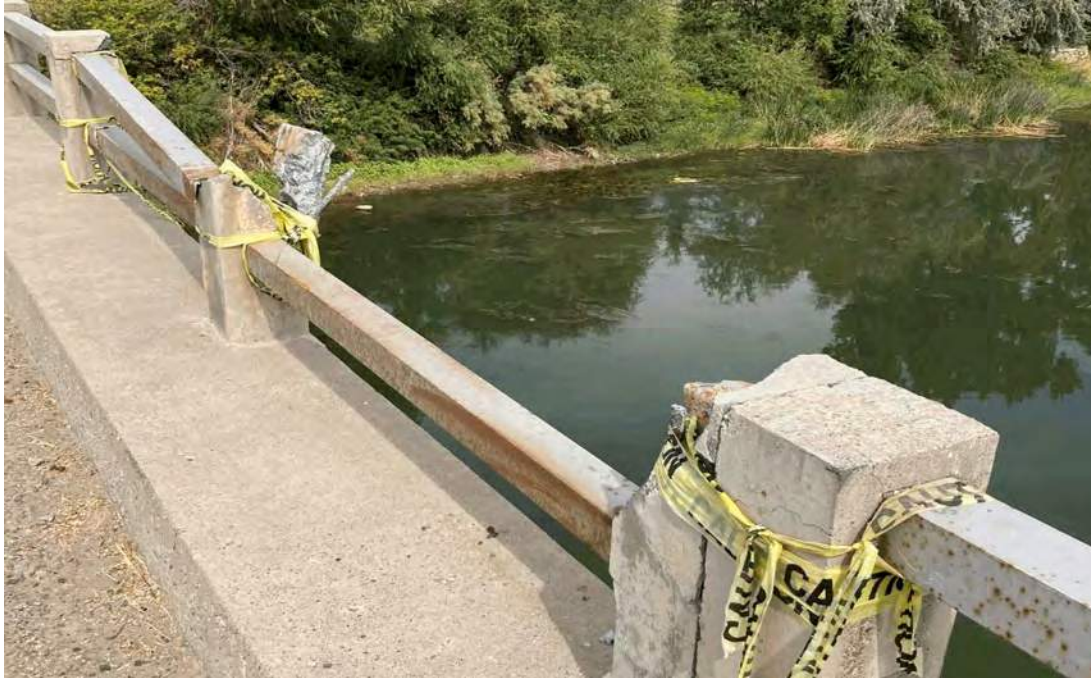
33. New rail damage, left rail, span 2, about 6 rail posts away from pier 3

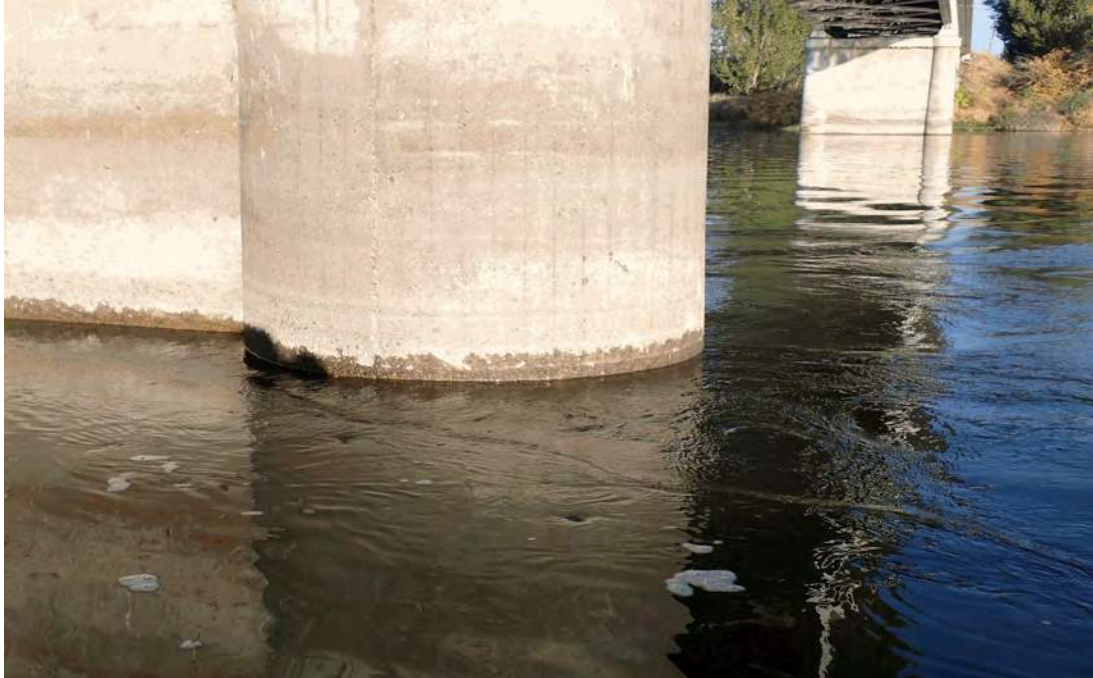
Typical condition of concrete at waterline looking southwest.
