# Thirteenth Coast Guard District Waterways Analysis and Management System

Northern Oregon Coast- 200100122210  
Tillamook Bay, Garibaldi Channel  
Completed: August 2019

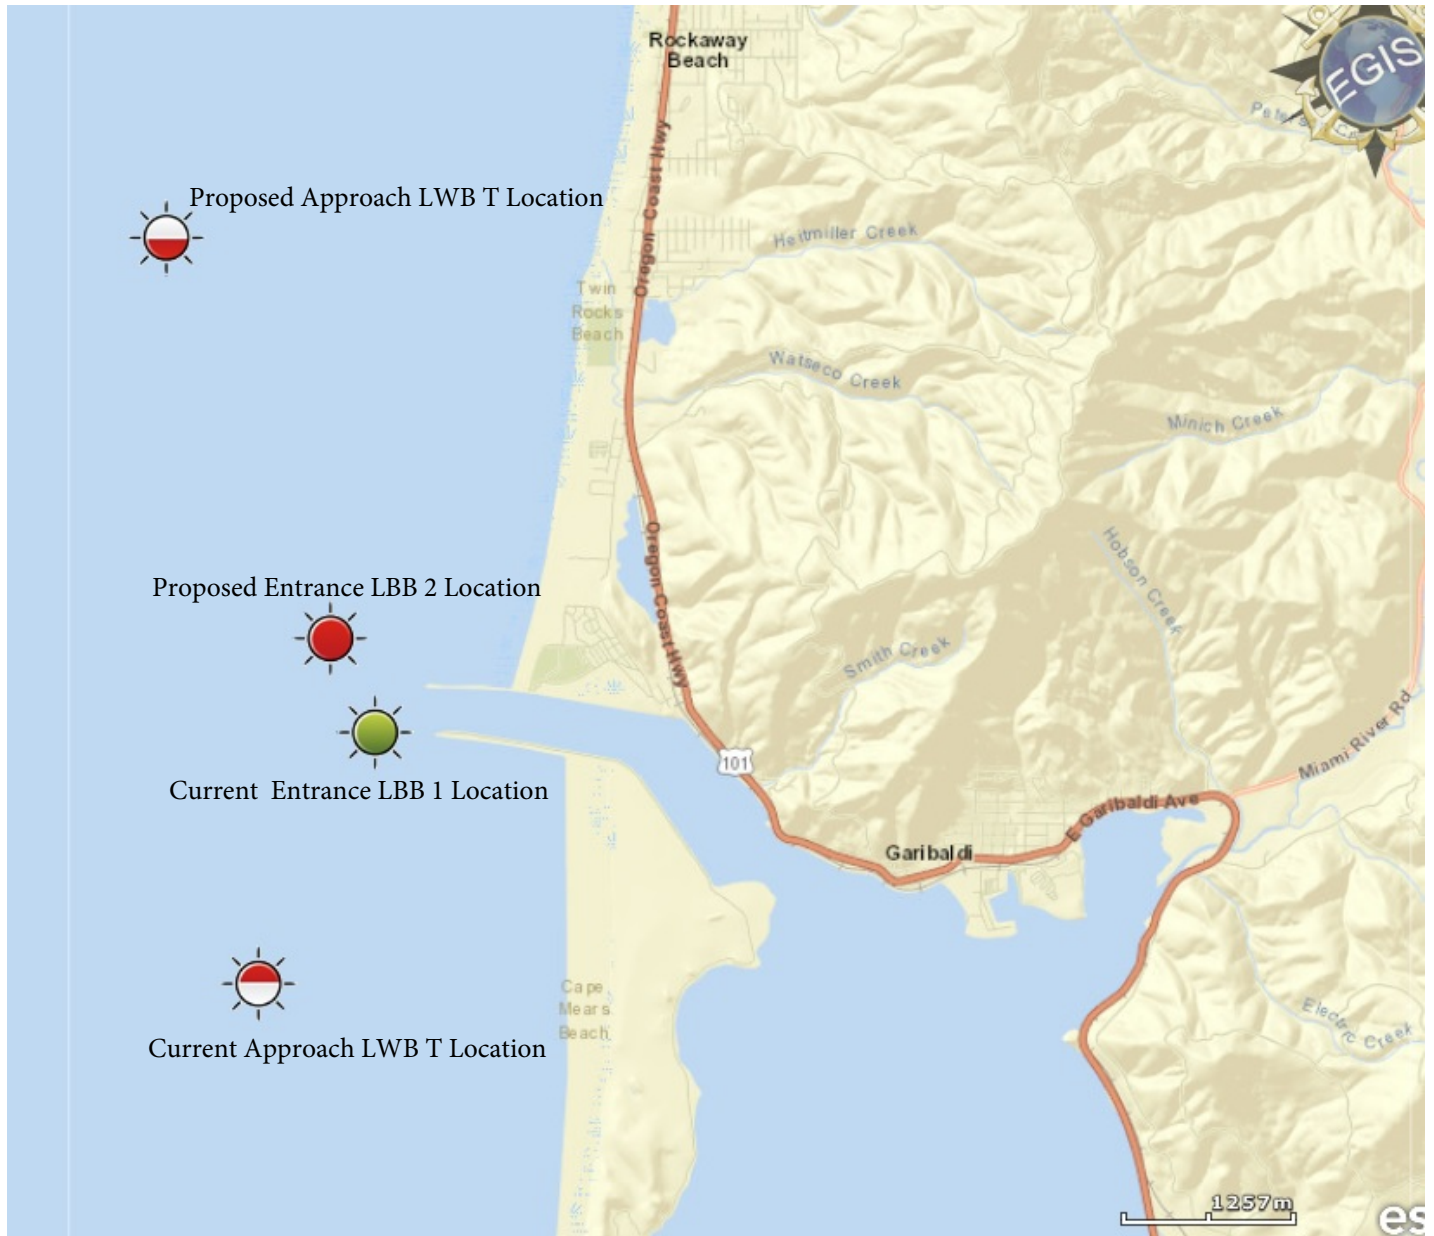
# Enclosure (09): Approach LWB T and Entrance LBB 2 Locations

This analysis was initiated due to concern over the bar crossing and built up shoaling of the south hole entrance where Entrance Lighted Bell Buoy 1 is located. Over the years, this bar crossing has been realigned with different buoy locations, to include a due west approach across the dangerous “middle grounds” and a southerly approach through the “south hole”. As current conditions stand now, the North Jetty has been rebuilt and the South Jetty has slowly deteriorated creating a shoaling effect and current bottom depths of 18 ft in vicinity of buoy 1. The overwhelming response from STA Tillamook crew and recreational/commercial mariners on the waterway is to relocate the approach to the north and disestablish the south hole approach. STA Tillamook has indicated that they frequently have to place bar restrictions due to the wave action over the south hole, when an approach based off the north jetty would be reasonable and not require restrictions. Making an approach from the south over shallow grounds is compounded by the fact that there is about 100 yards of the south jetty that has deteriorated and is submerged, not being visible to the mariner. This

creates a significant hazard to all vessels if not familiar with the area and a wide berth of the submerged jetty is not given. The recommended solution to this problem is to disestablish Entrance Lighted Bell Buoy 1 and establish a red Entrance Lighted Bell Buoy 2 roughly 500 yards north of the current Buoy 1 location and relocate Approach Lighted Whistle Buoy T approximately 5400 yards to the north of its current position creating a northerly approach and bar crossing avoiding the middle grounds and dangerous southerly shoaling (see enclosure 9).

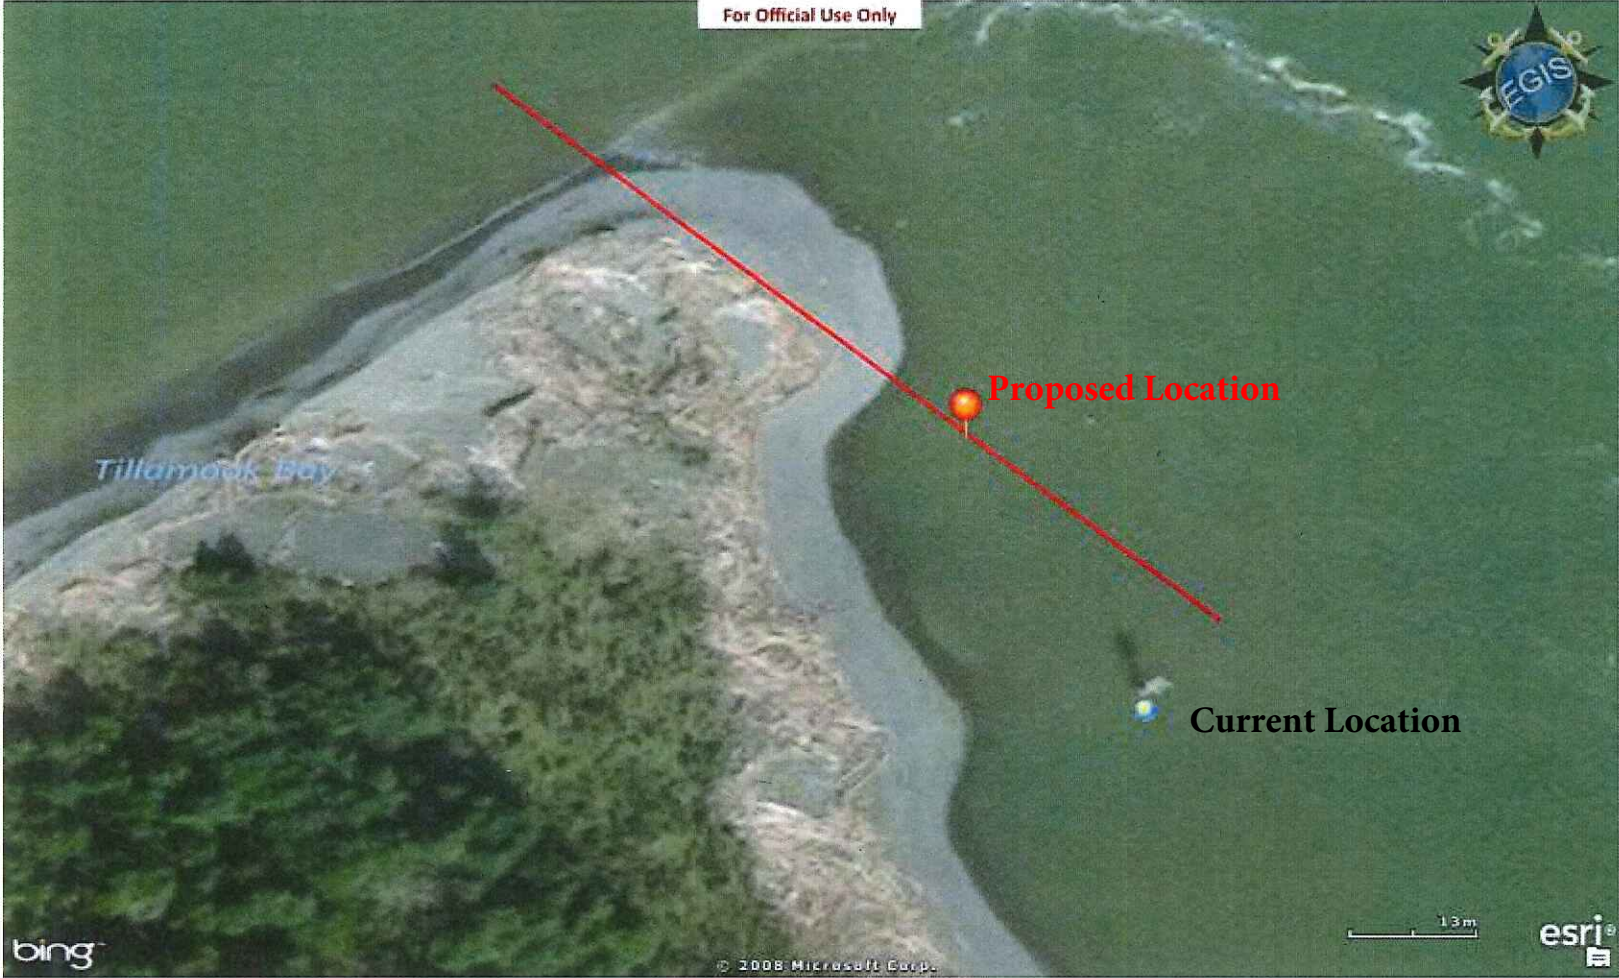
ENCLOSURE (10): Garibaldi Light 10 Relocation Proposal

It was also noted that Garibaldi Channel Light 10 is very difficult to see for smaller vessels while returning from sea into Tillamook Bay due to its positioning being protected behind Kincheloe Point. Recommend that when the aid is rebuilt as per the pending ATON order projects, that it be rebuilt as a 3-pile structure, 18' above waterline height in position 45-33-29.012N, 123-56-03.808W (see enclosure 10). This location would allow incoming vessel traffic a much better view of the aid and reduce the risk of running aground into the point.

New Garibaldi Channel LT 10 45-33-29.012N 123-56-03.808W or SW towards shore
